# Filament Folding in Splicer Area

This issue occurs when filament gets caught and folds over on itself within the Teflon block of the splicing area.

Written By: Mosaic Support

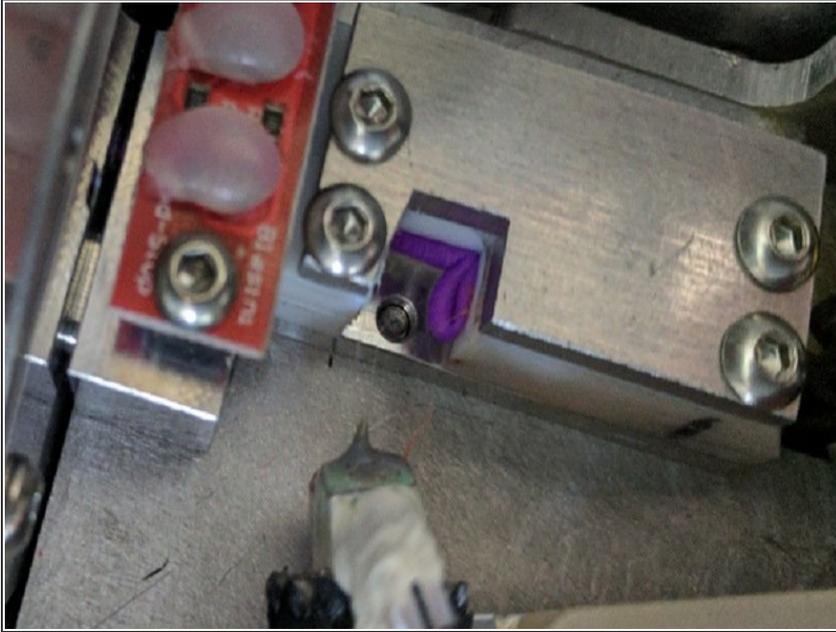
## Step 1 — Clean Hot Tool

This issue occurs when filament gets caught and folds over on itself within the Teflon block of the splicing area. This can be caused by very curly filament being fed into Palette, or may be due to parts shifting slightly during the shipping process. To fix this issue, please follow these steps.

- Clean the hot tool, especially if you had completed a lot of printing prior to the error. Find the support article [here](#).
- Run *Calibration > Splicer Distance*. This re-calibrates the distance that the hot tool closes when splicing/welding filament. If it closes too much, the hot tool's stepper will "bounce back", which can pull the filament and cause the filament to fold. Too little and the splices will not be strong enough.
- Run Palette in *Splice Demo > Without Printer* mode to examine splices.
