# Filament Folding in Splicer Area

This issue occurs when filament gets caught and folds over on itself within the Teflon block of the splicing area.

Written By: Mosaic Support

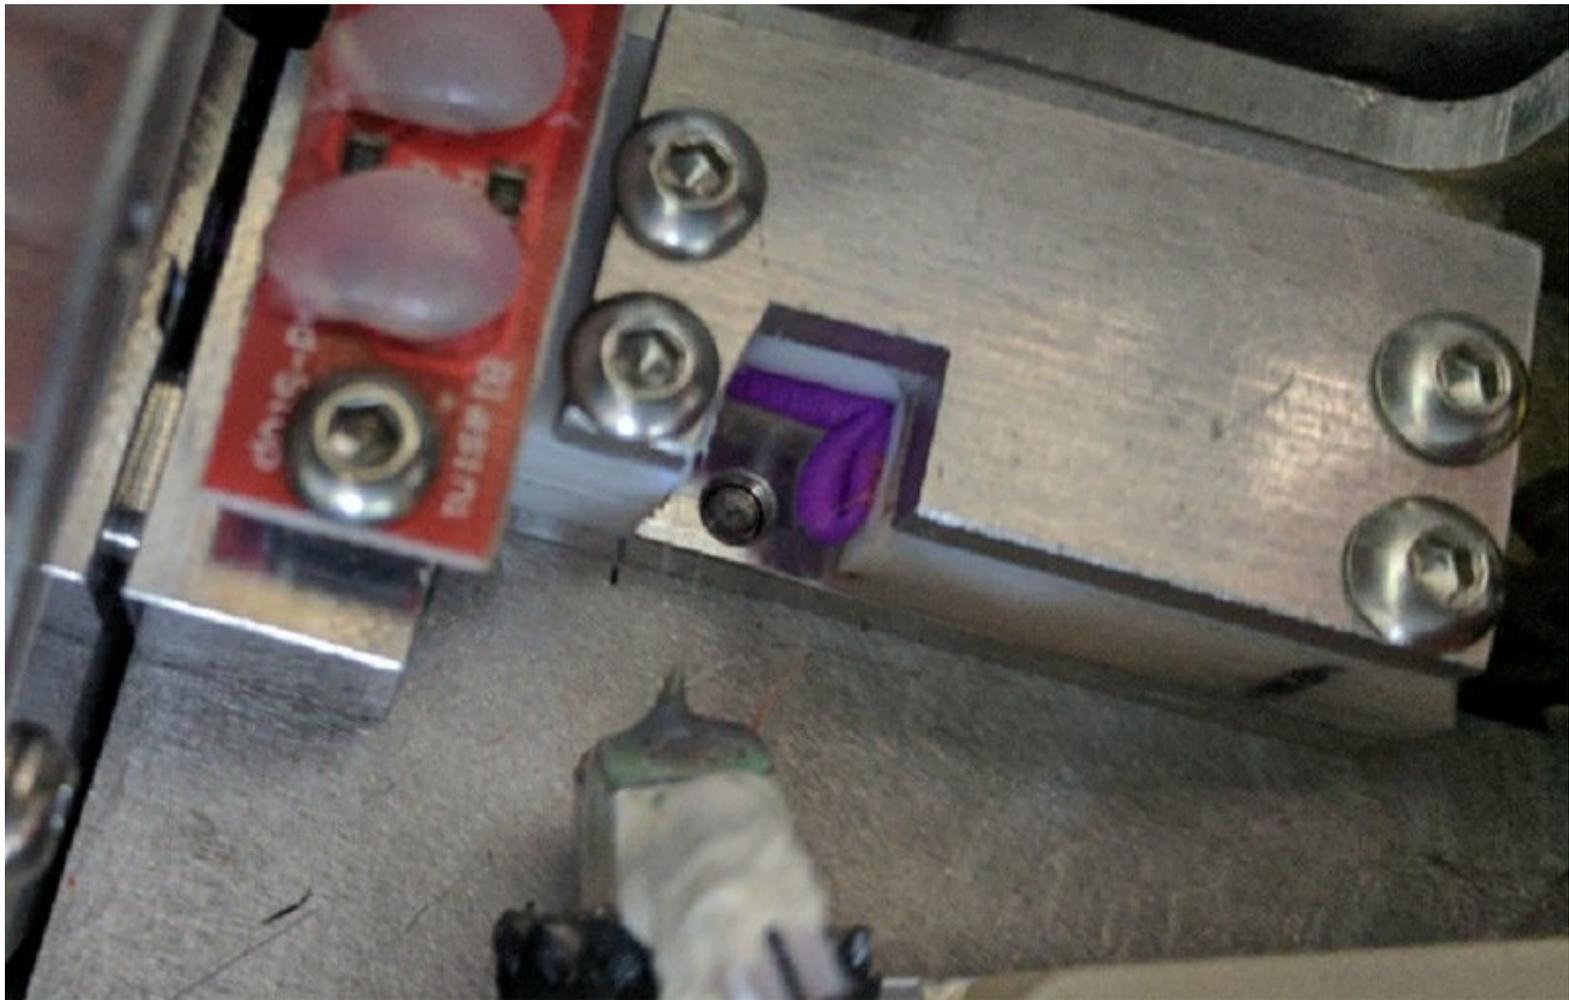
This issue occurs when filament gets caught and folds over on itself within the Teflon block of the splicing area. This can be caused by very curly filament being fed into Palette, or may be due to parts shifting slightly during the shipping process. To fix this issue, please follow these steps.

- Clean the hot tool, especially if you had completed a lot of printing prior to the error. Find the support article [here](#).
- Run *Calibration > Splicer Distance*. This re-calibrates the distance that the hot tool closes when splicing/welding filament. If it closes too much, the hot tool's stepper will "bounce back", which can pull the filament and cause the filament to fold. Too little and the splices will not be strong enough.
- Run Palette in *Splice Demo > Without Printer* mode to examine splices.
