Replacing the Heat Cartridge

If Palette's hot tool does not reach the proper splicing temperature after a long period of time, there are a few steps to troubleshoot.

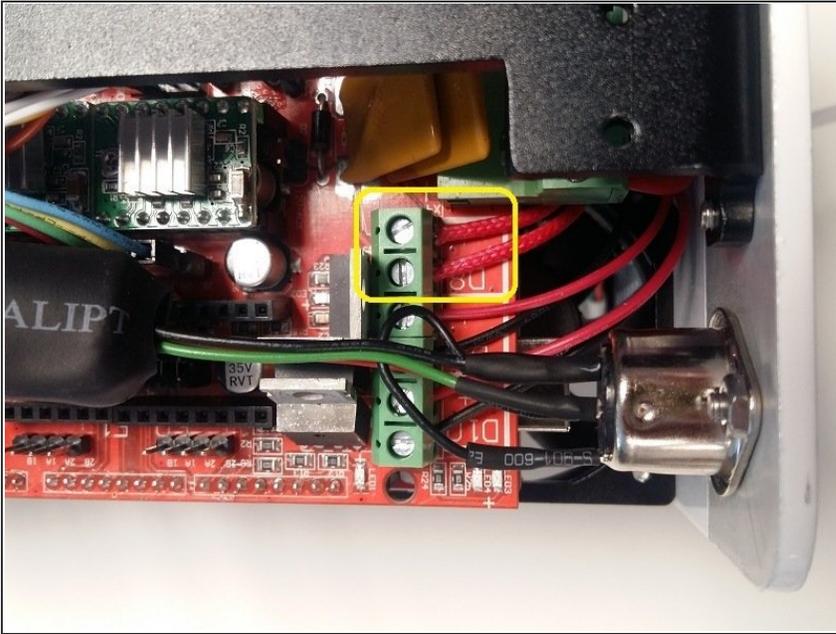
Step 1 — Check Temperature

- Re-flash Palette+'s firmware and on Palette+'s screen, go to *Utilities > Preheat*. Check to see if the temperature reaches 230C.
- Check that the connections of the heat cartridge to the electronics tray are firmly attached. This can found at D8.
- Ensure that your unit is receiving enough power by checking that the power supply and cables are secure and that the blue light appears on the power brick.
